Appendix G: Field Testing and Evaluation of WAVE/DSRC Communications Functionalities

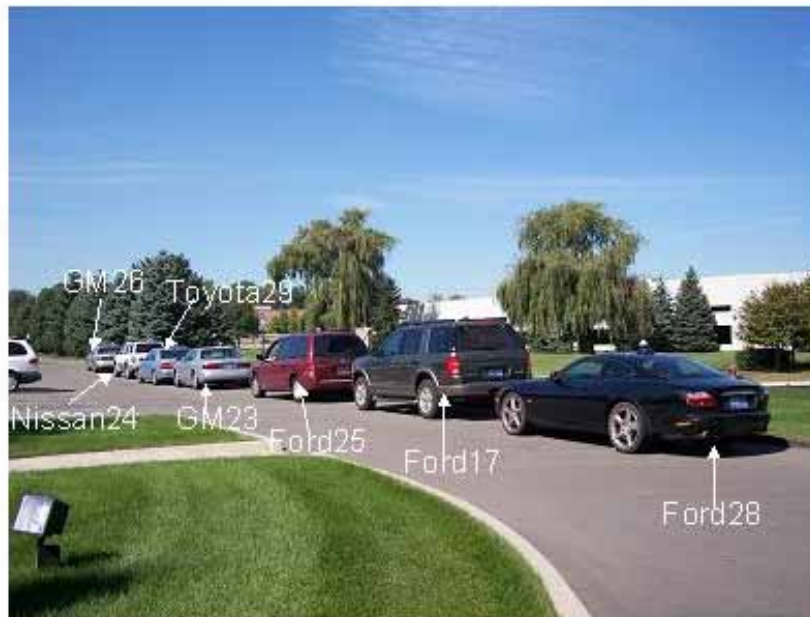
Figure 112. Seven Vehicle Caravan

Vehicle-to-vehicle communications testing was conducted on the I-96 freeway and M-5 ramp in Michigan in order to evaluate the communications performance on freeways. Seven vehicles – GM26, Nissan24, Toyota29, GM23, Ford25, Ford17 and Ford28, formed a caravan as shown in Figure 112. The caravan consisted of 4 sedans, 2 SUVs and a minivan. All seven vehicles were equipped with a DGPS Max receiver and antenna, WRM, and the Task 9 application running on a Laptop. The vehicle position information was obtained from the DGPS Max receiver that was configured to obtain differential corrections from the US Coast Guard beacons. One roof mount DSRC antenna (developed under the VSC Task 6C project) was used on the vehicles.

Three of these vehicles, Ford28 (Jaguar XKR developed by Ford for the EDMap project), GM23 and GM26 (both Buick Lesabres developed by GM for the ACAS project), had software modifications carried out so that they provided the vehicle signals over the CAN interface as defined in the Task 9 application. In all these tests, the WRMs were configured to send and receive on the DSRC Control Channel, which is Channel 178 with a center frequency of 5890 MHz and a 10 MHz bandwidth.

As shown in Figure 112, GM26 is the lead vehicle followed by Nissan24, Toyota29, GM23, Ford25, Ford17 and Ford28 respectively. The caravan was made up of 4 sedans, 2 SUVs and a minivan. The WRMs on all vehicles were configured to both send and receive data. The results for a small segment of this test scenario are shown in Figure 113 through Figure 118. Distances between Ford28 and other vehicles were calculated from V-V communication received by Ford28. The distances are color-coded based on the received signal strength indicator (RSSI) values for the packets received by Ford28.

As shown in Figure 112, GM26 is the lead vehicle followed by Nissan24, Toyota29, GM23, Ford25, Ford17 and Ford28 respectively. The WRMs on all vehicles were configured to both send and receive data. The results for a small segment of this test scenario are shown in Figure 119 through 124. Distances between Ford28 and other vehicles were calculated from V-V communication received by Ford28. The distances are color-coded based on the received signal strength indicator (RSSI) values for the packets received by Ford28. Figure 120 shows the speeds for a small segment of this test scenario, color-coded based on the brake status, of GM26 and GM23 using data received by Ford28. Figures 121 through 123 show the yaw-rate, longitudinal acceleration and lateral acceleration respectively of GM26 and GM23 for a small segment of this test scenario based on data received by Ford28.

As shown in Figure 112, GM26 is the lead vehicle followed by Nissan24, Toyota29, GM23, Ford25, Ford17 and Ford28 respectively. The WRMs on all vehicles were configured to both send and receive data. The results for this test are shown in Figures 125 through 130. Distances between Ford28 and other vehicles were calculated from V-V communication received by Ford28. The distances are color-coded based on the received signal strength indicator (RSSI) values for the packets received by Ford28. Figure 126 shows the speeds, color-coded based on the brake status, of GM26 and GM23 using data received by Ford28. Figures 125, 126, and 127 show the yaw-rate, longitudinal acceleration and lateral acceleration respectively of GM26 and GM23 based on data received by Ford28.

Vehicle-to-vehicle communications testing was conducted on the I-96 freeway and M-5 ramp in Michigan in order to evaluate the communications performance on freeways. Seven vehicles – GM26, Nissan24, Toyota29, GM23, Ford25, Ford17 and Ford28, formed a caravan as shown in Figure 112. The caravan consisted of 4 sedans, 2 SUVs and a minivan. Three of these vehicles, Ford28 (Jaguar XKR developed by Ford for the EDMap project), GM23 and GM26 (both Buick Lesabres developed by GM for the ACAS project), had software modifications carried out so that they provide the vehicle signals over the CAN interface as defined in the Task 9 application. Based on the V-V communications testing on freeways the following conclusions can be made:
